Assessment of Road Surface Condition Using Digital Image Processing

Abstract. The Road Surface Monitoring (RSM) is an essential activity which is used for the assessment of road surface distresses in order to provide adequate repairs in time. However, with the incessant growth in vehicular population, the road agencies are now facing problems related to the inspection and maintenance of the increasing road lengths. It is estimated that every year infrastructure worth billions of dollars is lost due to premature failure of roads as a result of inadequate maintenance. Apart from the lack of funds, one of the major reasons for improper management or delay of road maintenance activities is due to the currently used traditional road inspection methods. These methods are expensive, create interruption to the moving traffic and often delay the maintenance process. In the recent years, various attempts have been made for automating the data collection process in the form of videos and images by using different imaging systems. However, the analysis and processing of the collected data in order to quantify the extent of surface deterioration is still predominantly done manually. The presen

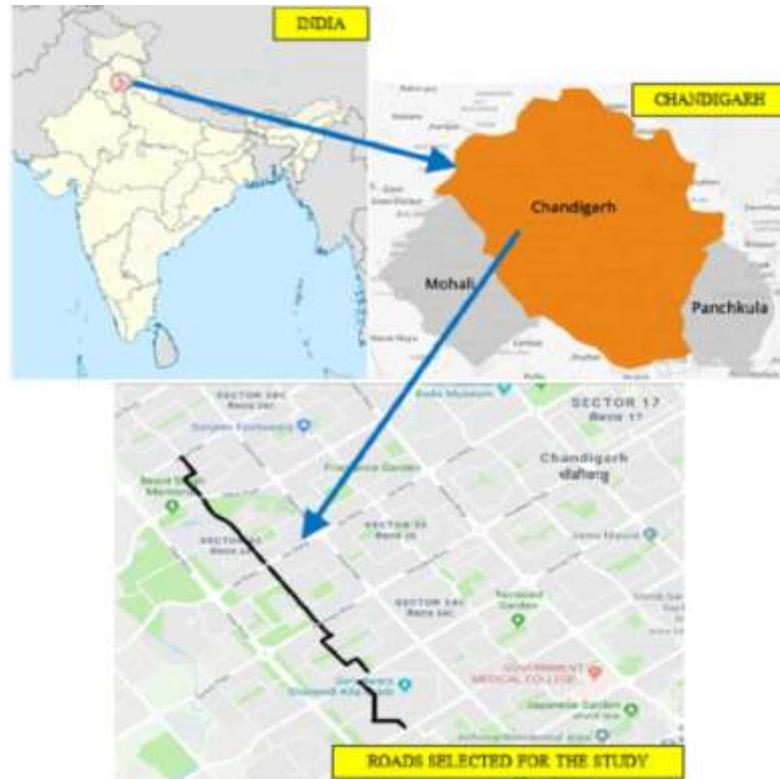
Figure. 1. Roads Selected for the Study

This organized arrangement of road infrastructure leads to a remarkable hierarchy of traffic movement and at the same time ensures that the residential areas are segregated from the noise and air pollution of traffic. However, with time and increasing urbanization the city has developed beyond its designed capacity. However, in spite of having a well-designed and planned road network, the city is currently facing congestion related problems because of the extensive increase in the number of motorized vehicles, which grew up from about 0.74 million in the year 2010 to 1.37 million in the year 2016 [19]. The excessive traffic volume on Chandigarh roads drives a need for the periodic assessment of road condition so as to maintain their efficiency. In the present study, an automated approach is used for assessment of surface condition of selected V4 type of roads and a GIS based database is created for the relevant road information data. The study area along with the selected roads is shown in fig. 1.

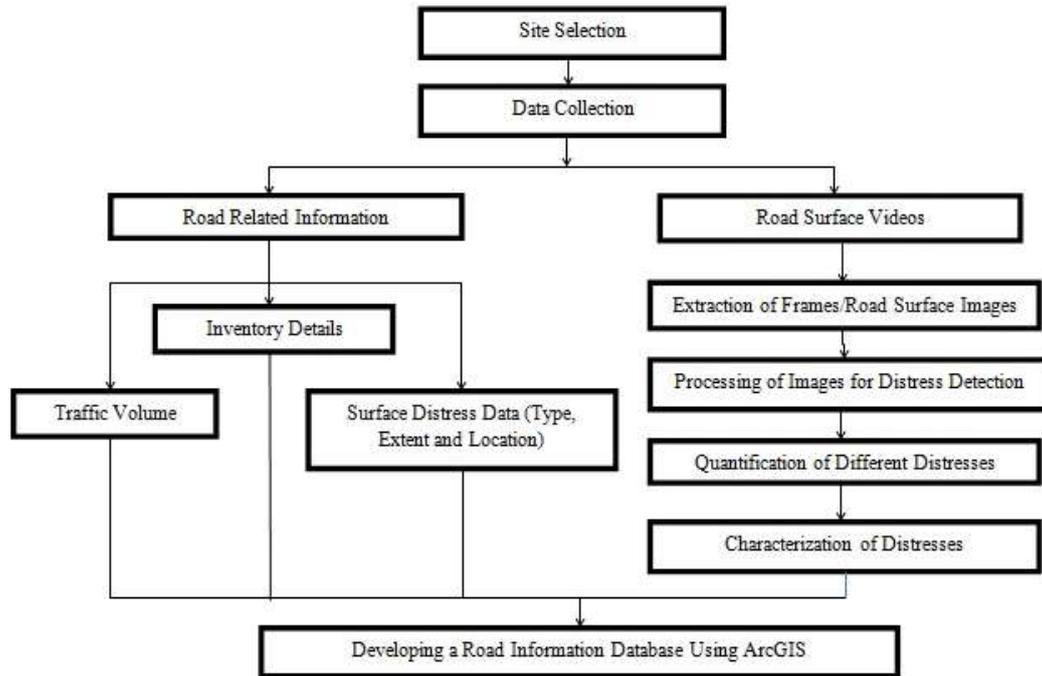
Figure. 2. Overall Methodology

The overall methodology used in this study was divided into different steps as shown in fig. 2.

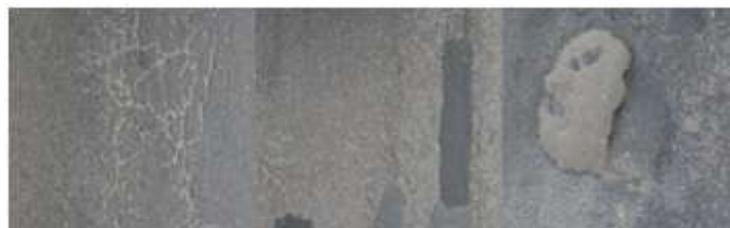
Figure 3. Common types of defects on the selected roads

The most common type of defects observed on these roads included patches, potholes and cracks (fig. 3). The surface condition data collected through manual survey was further used for validating the results obtained from proposed approach.

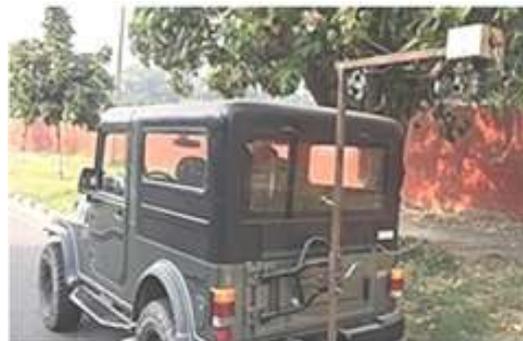
Figure. 4. Camera setup for recording road surface videos

A high resolution DSLR camera (1920 x 1080, 60 frames/sec) was mounted at the back of a survey vehicle at a height of 2 m above the ground (fig. 4) to record the videos of the road surface. The camera was connected with a laptop placed inside the survey vehicle, so as to control and save the recordings without any interruption from the vehicle itself. The on road area covered by one video frame was approximately 4.05 m² with 1.39 mm pixel size, which was sufficient enough to provide a detailed description of the distresses from the images. No artificial means of lighting was used during the recording of the videos. A total of 1454 images (frames) were then extracted from the videos [21] which included images of distresses and distress free road surface.

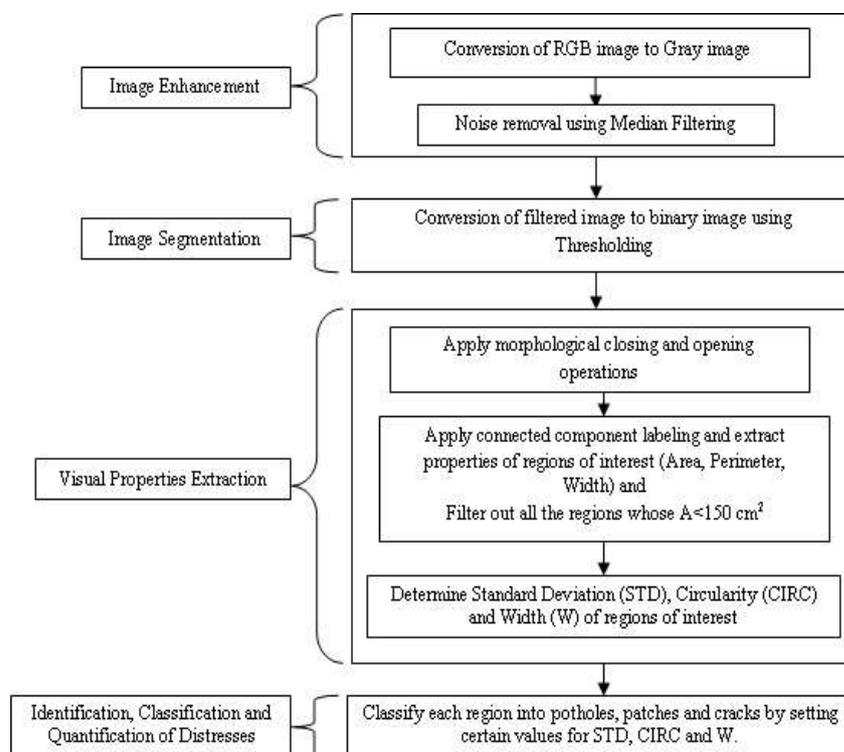
Figure. 5. Algorithm for automated identification and classification of road distresses

The extracted images (frames) were then processed in MATLAB 2015a with the help of various image processing techniques for the detection and classification of different distresses. The algorithm proposed for the study (fig. 5) consisted of five main steps which include image enhancement, image segmentation, extraction of visual properties of distresses, detection and classification of distresses and finally quantification of distresses.

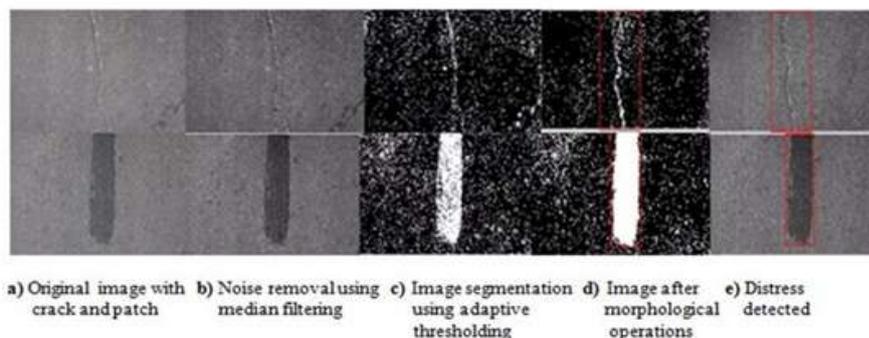
Figure 6. Procedure applied to detect distress

The image enhancement was done by converting the extracted image format from 24 bit to 8 bit so as to make the image compatible to the proposed processing techniques and to save processing time. In order to remove/reduce noise from the acquired images, median filtering was applied to the gray (8-bit format) image. The size of the neighborhood used for filtering was 5 x 5 pixels [22]. The next step was image segmentation [23], [24] which was done to determine which pixels belong to region of interest. It was performed using adaptive thresholding based on the weighted mean of neighborhood area [22]. The optimal neighborhood region and the value of constant were determined by trial and error method. After the application of adaptive thresholding, the gray image is converted into a binary image with black pixels representing the road surface and white pixels representing a distress or noise. Further processing of the binary image was done using morphological operations (erosion and dilation) and connected component labeling so as to extract the visual properties of the distresses [22]. On the application of the above techniques, an image containing the possible regions of interest is obtained. For the purpose of simplification of the distress detection process, only the regions of interest (distresses) with area more than 150 cm² were considered for the study. The minimum value of area used in the present study can be altered in accordance with the respective requirements. The extracted visual properties such as STD, CIRC and W were then used to automatically classify various distresses using user defined decision logic. Depending upon the results from the manual inspection, the decision logic was developed by testing the different values for extracted properties on about 120 images containing cracks, potholes and patches. The procedure applied to detect distress using the proposed algorithm is shown in fig. 6.

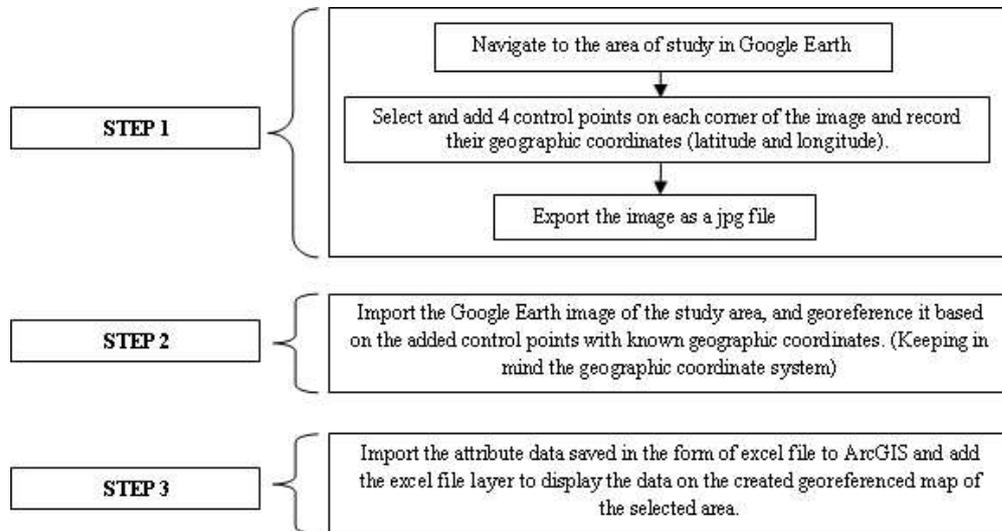
Figure. 7. Steps involved in creating road information database in ArcGIS

The Google Earth Images (.jpeg) of the selected roads were used for the representation of the ground data. The sequence of the steps involved in importing and plotting the data on ArcGIS platform is shown with the help of a flowchart (fig. 7).

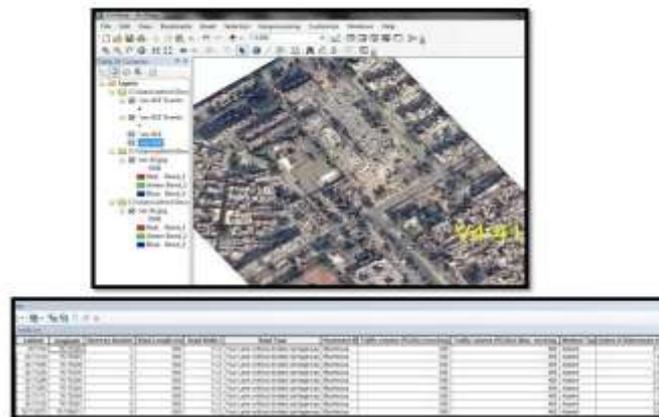
Figure. 8. Location of distresses plotted on the georeferenced map and the attribute table of road information

A typical display of road related information in the form of attribute table along with the locations of distresses is shown in fig. 8.
